THAT'S THE BRAKES Inherent By Design or Installer Error?

GM's N BODY PLATFORM

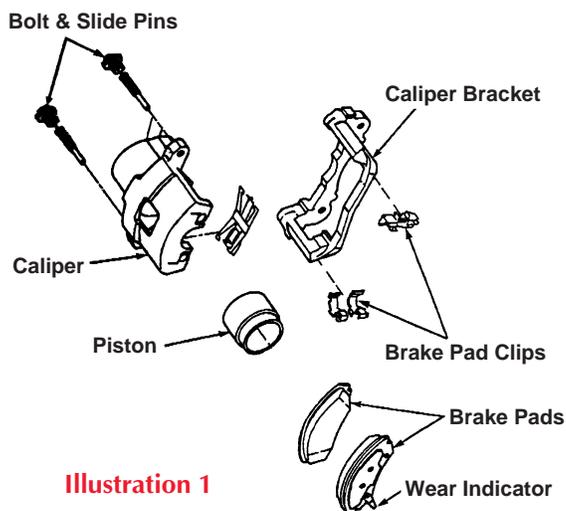
Illustration 1

Were the disc pads correctly installed? The GM service manuals and some independent aftermarket manuals ***incorrectly*** reflect that the disc pad with the wear indicator should be positioned on the outboard side of the caliper (see illustration 1).

The above illustration from a service manual incorrectly reflects that the disc pad with the wear indicator is positioned on the outboard side of the caliper. When mounted correctly, the pad with the wear indicator is positioned on the inboard side next to the piston.

The pad with the wear indicator should be positioned on the **inboard side**, next to the piston. When the pads are correctly installed, the wear indicator on the inboard pad will be pointed upward. This establishes a right and left side inboard pad. Some precautions have been taken to prevent an incorrect installation, such as a longer tab on the center of the disc pad plate on the inboard pad. However, on some applications the tab length is not sufficient enough to prevent an improper installation, especially if the center anti-rattle clip is left off during a pad installation.

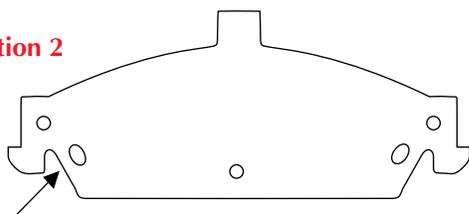
Illustration 2

If the disc pad with the wear indicator is positioned on the outboard side of the caliper, premature and tapered pad wear is certain. In this position, the skirt of the caliper will make contact with the D-shaped lugs on the pad plate, in which the wear sensors are staked onto the pads (see illustration 2). In addition to unequal pressure, a binding condition can occur with the caliper and caliper bracket. This prevents freedom of caliper movement on pedal release, keeping the pads against the rotor. GM has advised

D-Lugs for Wear Sensors to be staked on

that improperly installed pads can result in premature wear and wheel binding or total lock-up, when the space saver spare tire and wheel is installed.
